Scanning the Temple Mount

Monitoring changes in ancient walls

Jerusalem's Temple Mount: Historic Preservation with 3D Laser Scanning

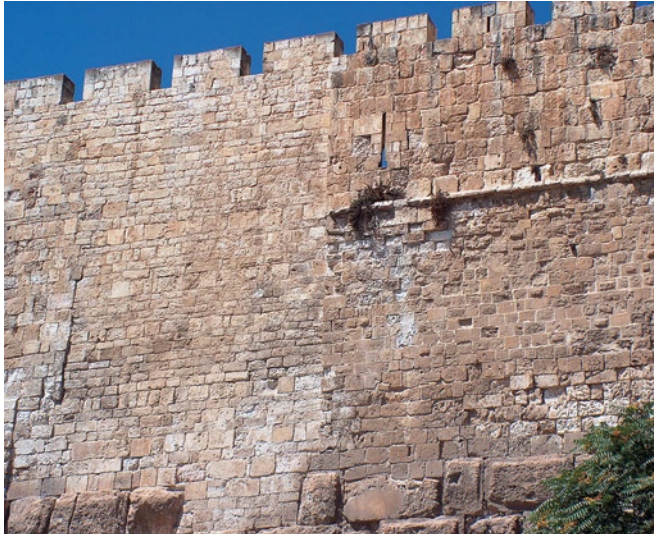
Figure 1 Eastern wall of Jerusalem's Temple Mount after earthquake-induced displacement. All images courtesy Israel Antiquities Authority and Mabat 3D Technologies Ltd.

Using this data, the Antiquities Authority determined that earthquake-induced displacement was not severe enough to threaten the wall's stability, Mabat reports, so immediate remediation was not needed.

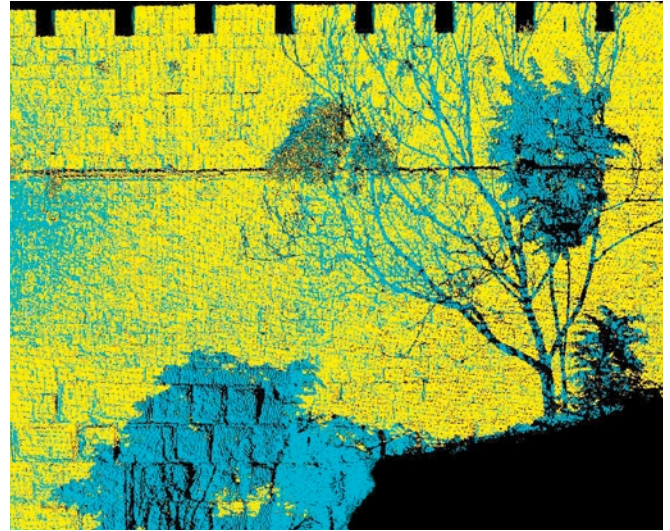
Figure 2 Eastern wall earthquake displacement analysis; point cloud with vegetation shadowing.

Post-processing and extraction of measurements were done in Cyclone. Deliverables were a TIN mesh showing the wall's geometry after the earthquake compared with before (**Figures 2 and 3**), and sections through the TIN mesh used to generate displacement maps (**Figure 4**). The TIN mesh and displacement maps were exported to AutoCAD at the client's request. For every hour of field time, 1.5 to 2 hours of office work were required, Degani reports.

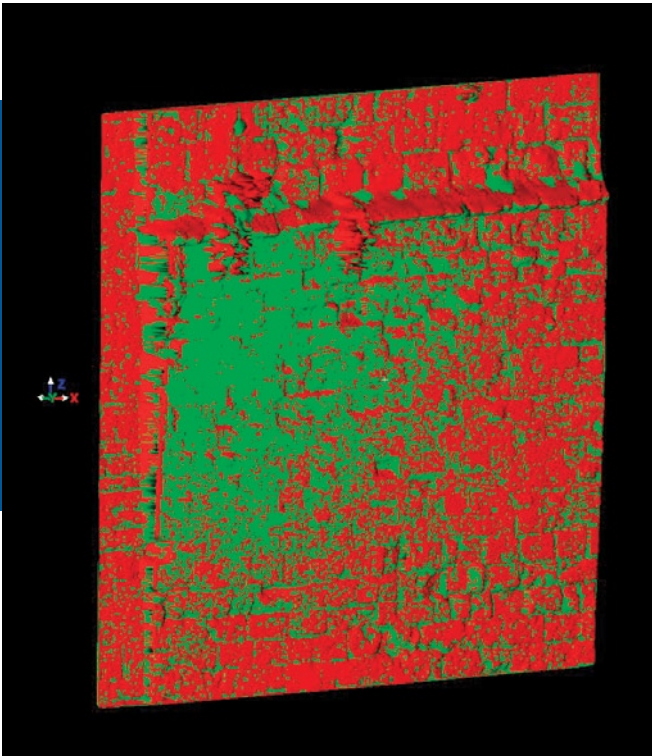
Figure 3 Eastern wall earthquake displacement analysis. TIN mesh showing displacement (red is pre-earthquake, green is post-earthquake).

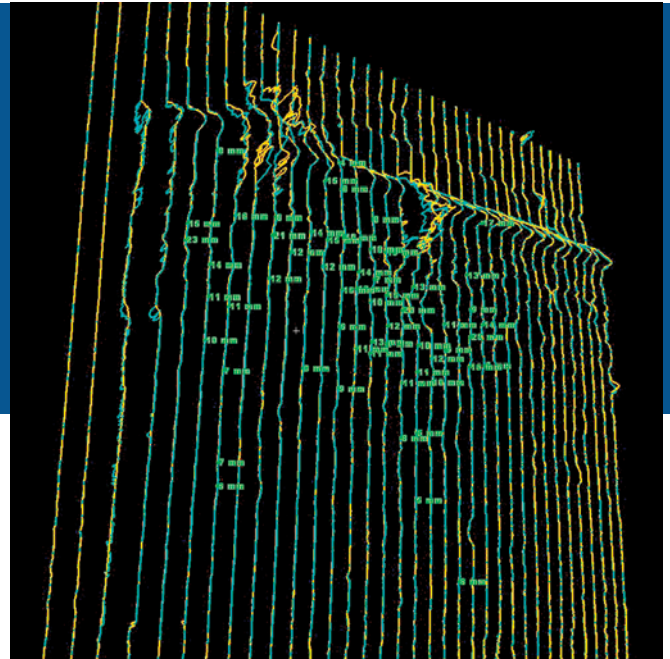
Figure 4 Eastern wall earthquake displacement analysis – sections through TIN mesh used to generate displacement maps.

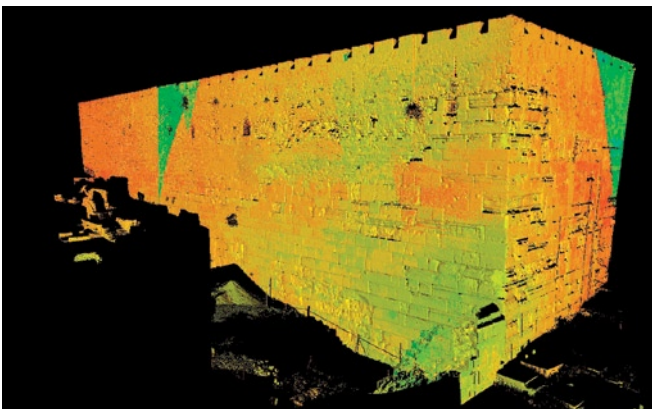
the firm was called in to document a bulge in a different location – in this case the mount’s southern wall (**Figure 5**). This bulge probably resulted from lateral loads exacerbated by construction and excavation activity on the mount, according to Mabat. “At the same time as scanning this bulge,” Degani notes, “we were asked to monitor the southern part of the eastern wall, from the south corner to about one hundred meters away.” Thus the firm had reference data on the eastern wall when the earthquake hit.

Figure 5 Southern and eastern walls captured during southern wall bulge analysis.

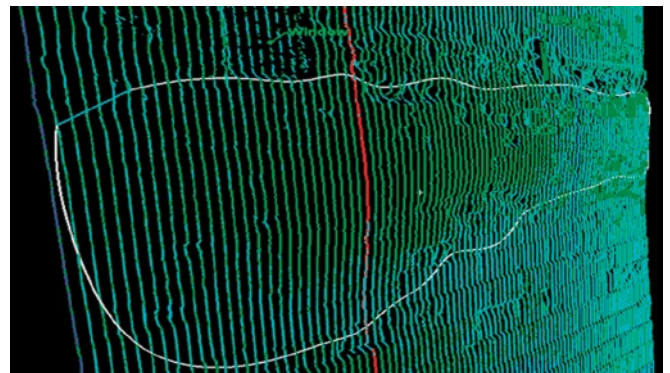
post-processing, Cyclone was used to cut sections through the point cloud every 25cm and generate contour lines (**Figure 6**). Displacements of 9-15mm were identified. This was judged significant, and repairs were undertaken as a result. *AS*

Figure 6 Southern wall bulge analysis – sections through point cloud every 25cm: Data shown in blue was acquired in initial scan; data shown in green was acquired in post-bulge scan. Wall displacement of 9-15mm in 6 months was judged significant, and repairs were carried out.
